A Cursory Examination of a Parachute Bag Knife, P/N 71172

ARL-TR-3892

September 2006

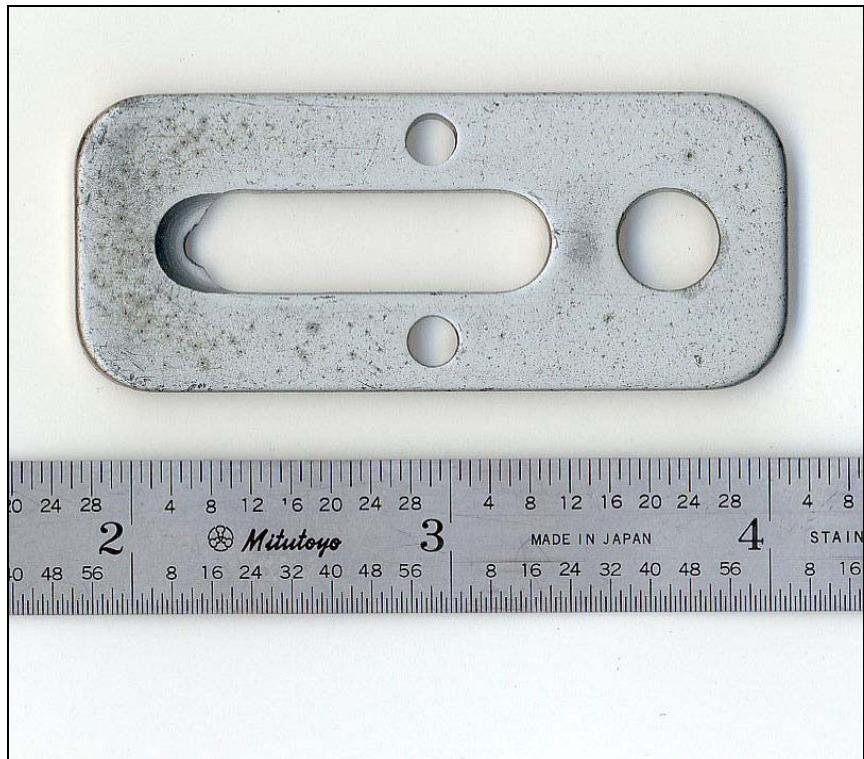
Figure 2. Bottom view of parachute bag knife, as-received (magnified 1.75×).

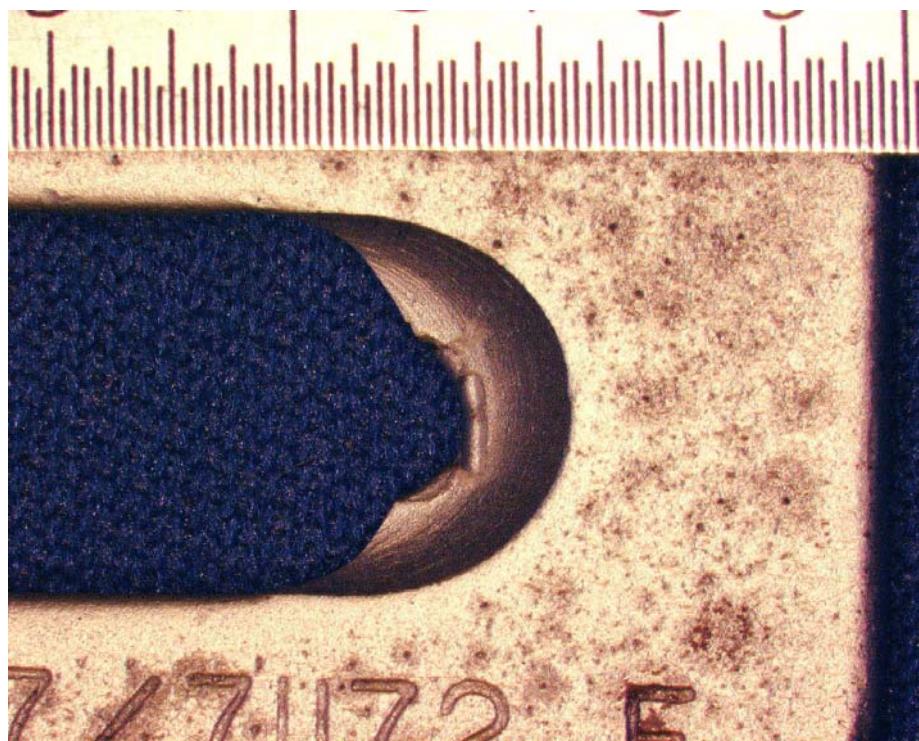
The as-received knife was photographed for documentation purposes (figures 1 and 2, representing the top and bottom of the part). As shown in the photographs, damage to the cutting edge was incurred. This anomaly is magnified in figure 3. The damage consisted of rolled metal, giving the appearance of a softer than nominal knife edge.

Figure 3. Damage to cutting surface, as-received (magnified 5×).

- The damage to the blade tip is evidence that the steel was softer than optimal for the intended purpose.
-

In general, knives are manufactured from quenched and tempered steel, resulting in a fine lath martensite microstructure. This is a much harder and tougher microstructure than pearlite and ferrite. It is recommended that future production of this component entail quenching and tempering of this alloy (per acceptable industry standards) to produce a part with a hardness in the upper 30's to lower 40's HRC. Heat treatment and hardness requirements should be added to Engineering Drawing 71172 to ensure quality components in the future. The U.S. Army Research Laboratory can provide assistance in this area if the U.S. Army Natick Research, Development and Engineering Center so chooses. In addition, it should be a requirement that the blade tip be ground after heat treatment. This would prevent decarburization from softening the tip.
